Dennistoun Community Council response to Glasgow City Council reply dated 5th October 2021 regarding queries submitted to the Dennistoun Area Partnership.

DENNISTOUN COMMUNITY COUNCIL
Observations along Hillfoot Street/Roslea Drive One-way section
+ additional references to other locations requiring maintenance

Monday 11th October 2021

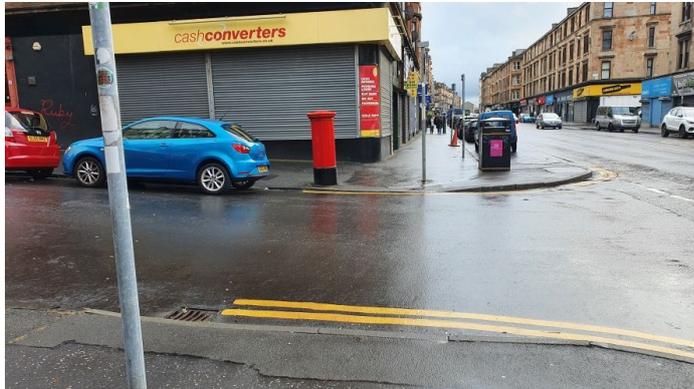
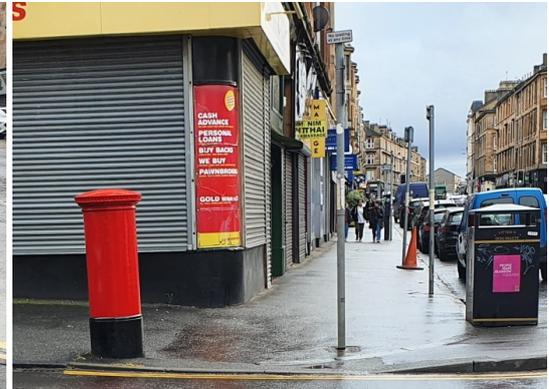
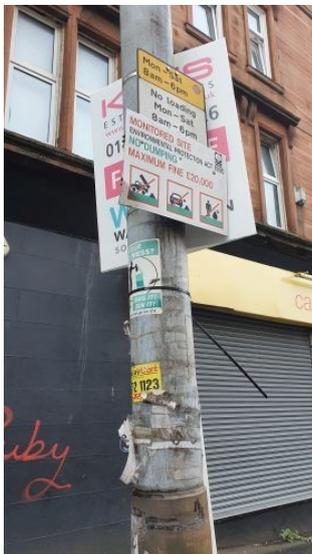
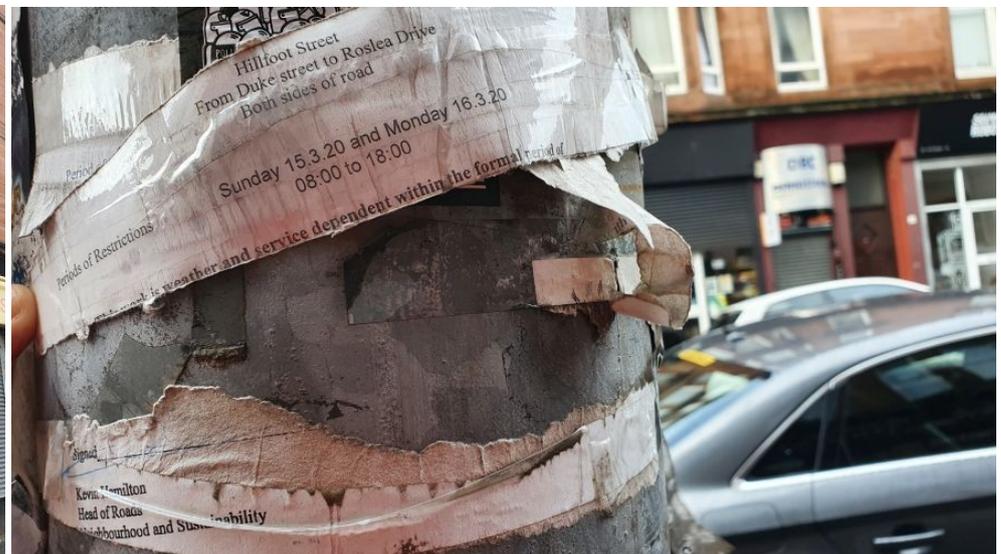
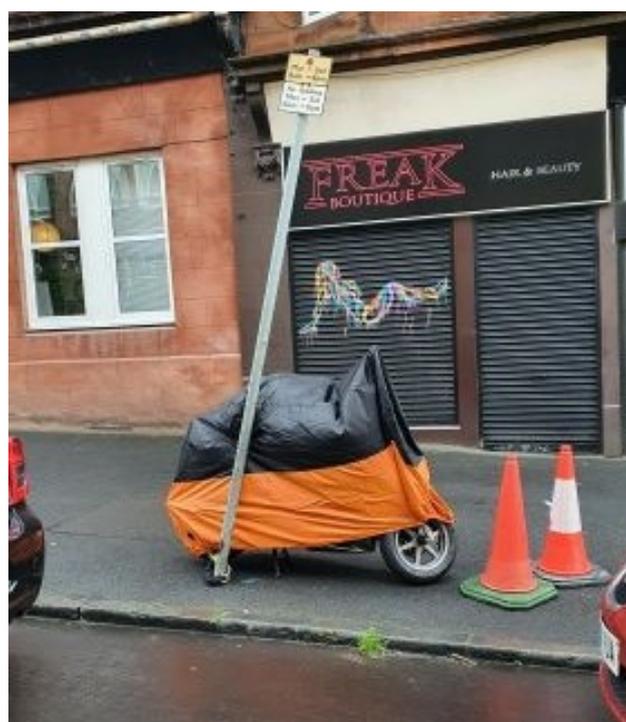
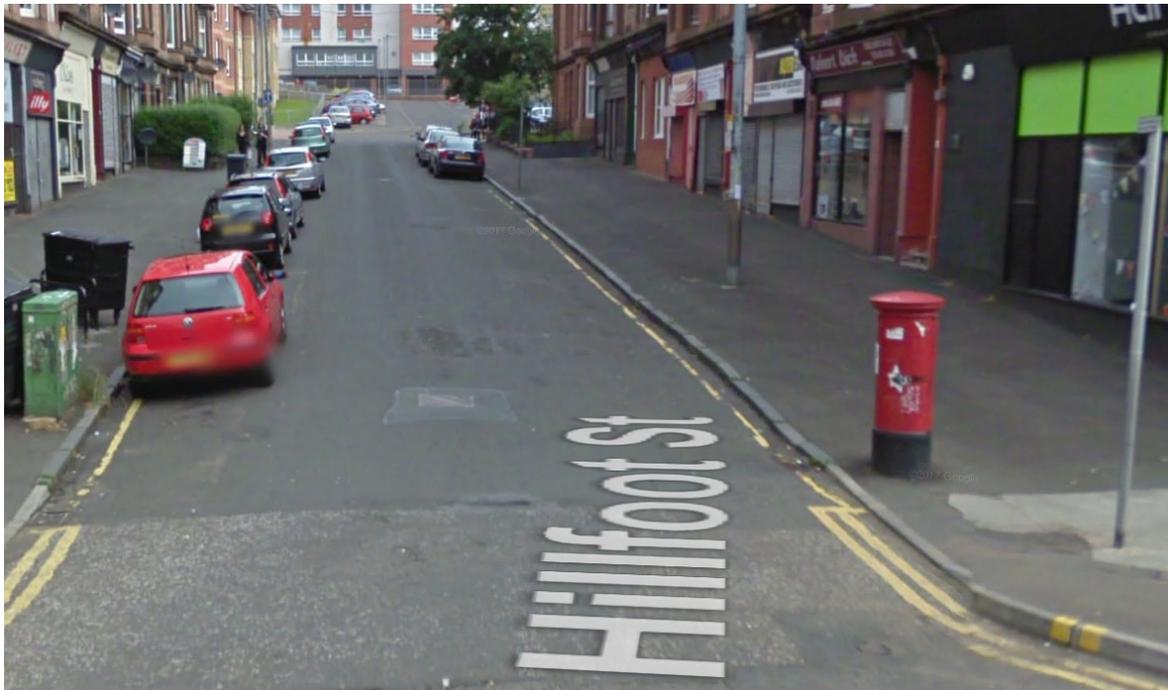
1) Hillfoot Street

- a) Apparent inconsistencies and/or contradictions (with StreetView image included for comparison):
 - i. Double yellows now terminate asymmetrically at gullies on each side, rather than what was apparently a measured and equal length previously;

- ii. No single yellow lining present now, compared to previously;
 - iii. No kerb markings present now, compared to previously;
 - iv. Signs for time-restricted parking and loading are still in place, as previously.

- b) Parking plate on bent pole.
- c) Parking information signs having to fight for attention with GCC 'Monitored site' dumping sign, GCC dog fouling sticker, remnants of an old GCC notification left behind after roadworks, minicab taxi sticker, estate agent sign, and multiple zip ties, all on the same rusting lighting column.

- d) Sign pole located absolutely central to desire line of pedestrian travel.
- e) Abandoned cones (three within view in these images, multiple others in very near vicinity).

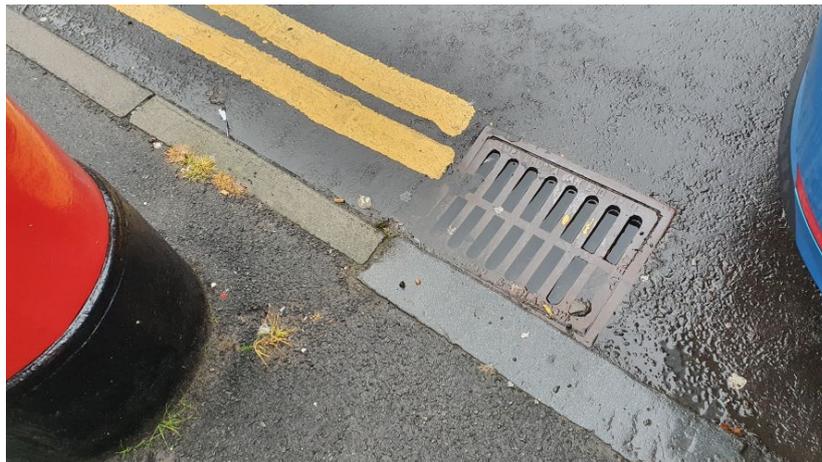
2) Hillfoot Street (+ other locations for blocked gullies, as listed)

- a) Blocked gully on east side of Hillfoot Street at Duke Street.
- b) Examples of long-term blocked gullies are also present nearby:
 - i. to east of Whitehill Street at Roslea Drive;
 - ii. outside Liquor City on Duke Street (No. 360, G31 1RE);
 - iii. on Armadale Street on NW corner of junction with Finlay Drive;
 - iv. in footway outside Mesa on Duke Street (No. 567, G31 1PY) at Armadale Street.

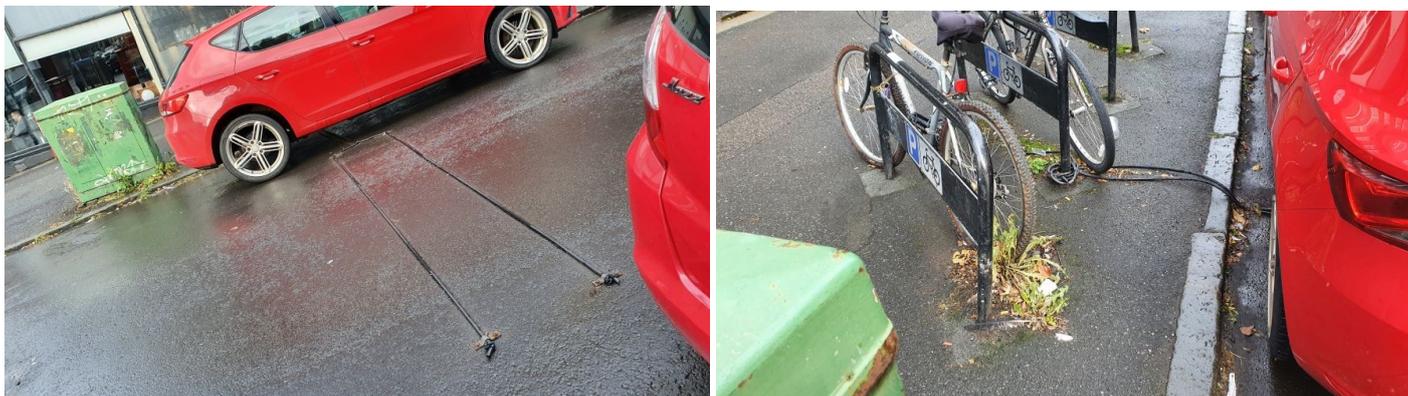
3) Hillfoot Street

a) Abandoned(?) traffic count cables.

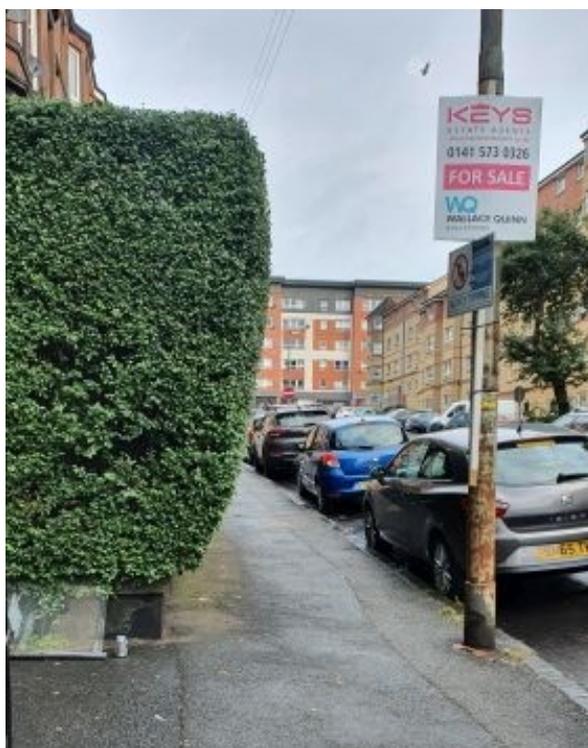
4) Hillfoot Street (+ other locations for significant vegetation, as listed)

- a) Fly tipping of glass shower panel/door, right next to fly-tipping sign overshadowed by estate agent sign on rusting lighting column.
- b) Overgrown vegetation significantly encroaching into footway space(see dry patch under overhang).
- c) Other significant examples of long-term overhanging vegetation nearby:
 - i. at corner of Whitehill Street and Ingleby Drive;
 - ii. at corner of Craigpark and Onslow Drive;
 - iii. at corner of Roslea Drive and Armadale Street;
 - iv. along north side of Duke Street between Tennent's and Lidl, and the path leading toward Ark Lane past the play park (requires substantial cutback and clearance of soil overflowing onto pavement).

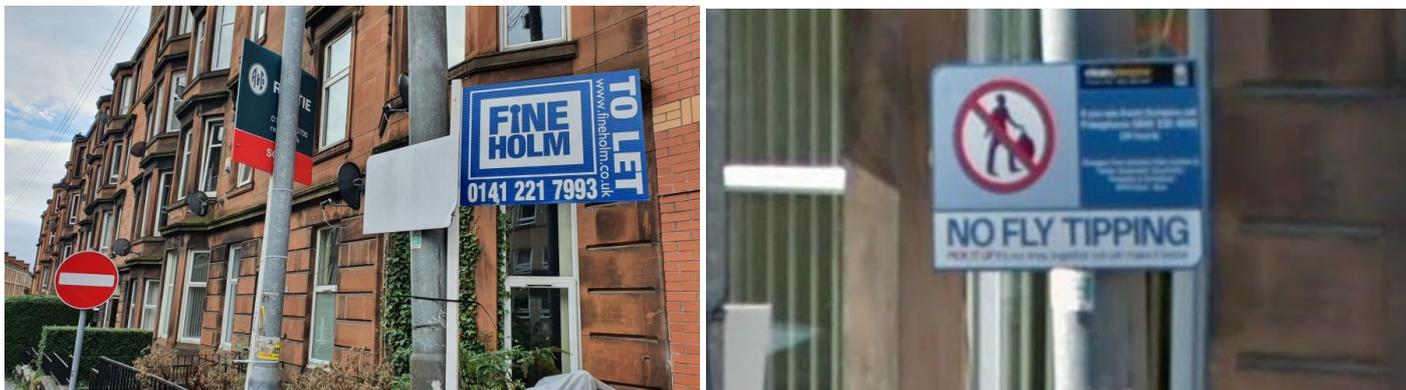
5) Hilfoot Street at Roslea Drive

- a) Fly tipping sign less than 30m away from above equivalent, now completely faded blank (old StreetView image included for reference), sitting alongside two estate agent signs on lighting columns.

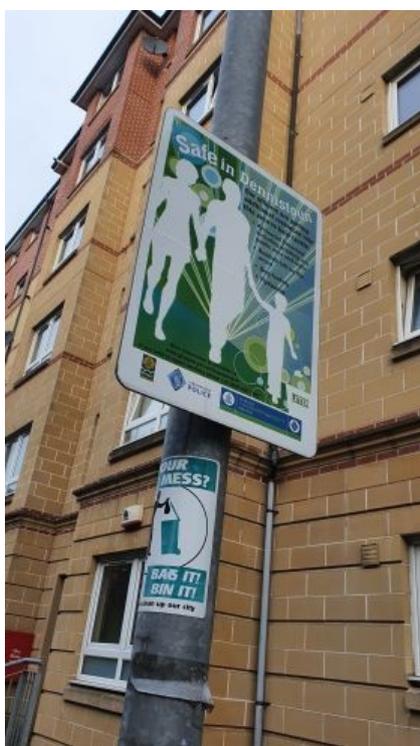
6) Roslea Drive at Hillfoot Street

- a) GCC 'Safe in Dennistoun' signs on Roslea Drive. Very little of the information on this sign seems to be current or active.
- b) GCC dog fouling sticker, again. Duplication of information on one pole– to what effect?

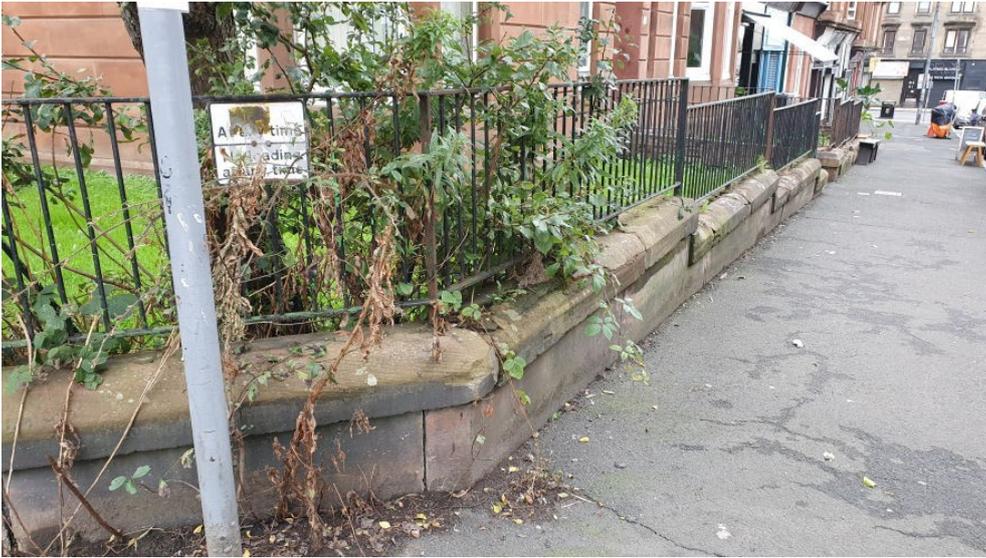
7) Roslea Drive/Hillfoot Street

- a) Parking signage in poor condition and obscured by vegetation, at corner of Hillfoot Street/Roslea Drive.

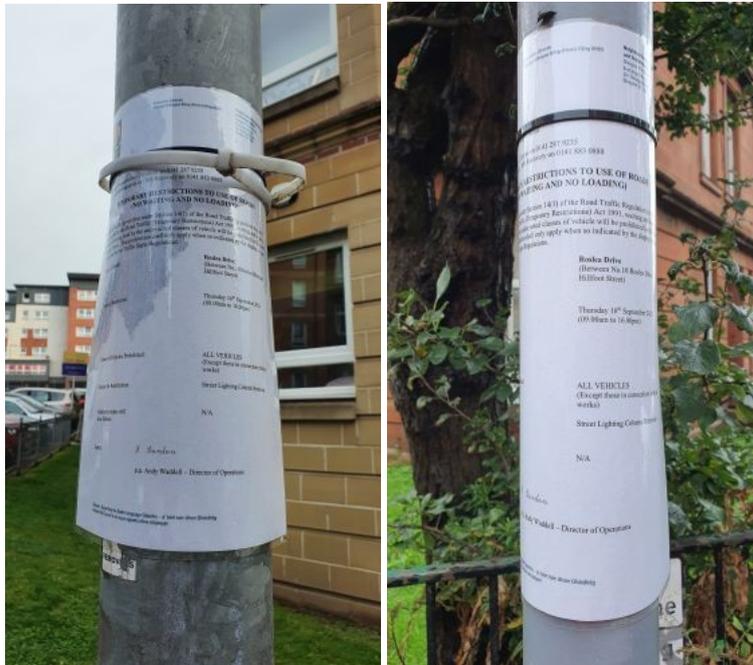
8) Roslea Drive

- a) GCC notifications not removed (for street lighting work on Roslea Drive, for dates now in the past).

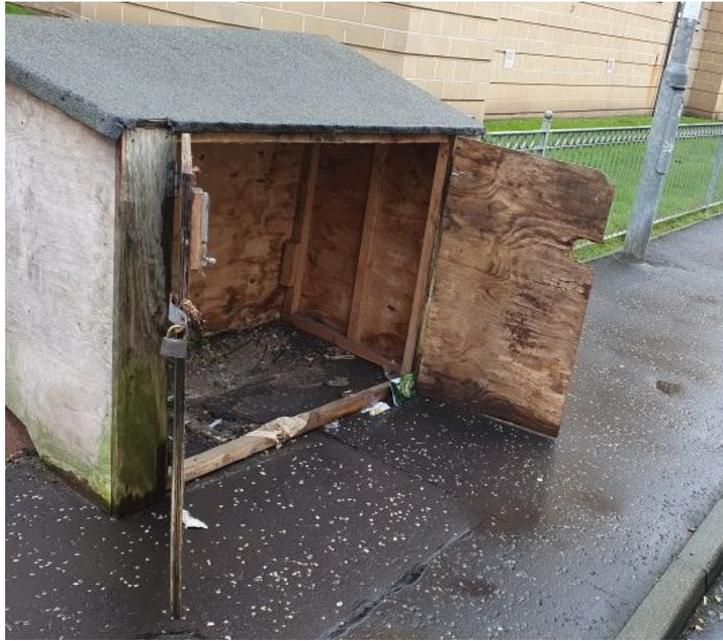
9) Hillfoot Street/Roslea Drive

a) Abandoned and empty timber 'cabinet' at corner of Hillfoot Street/Roslea Drive.

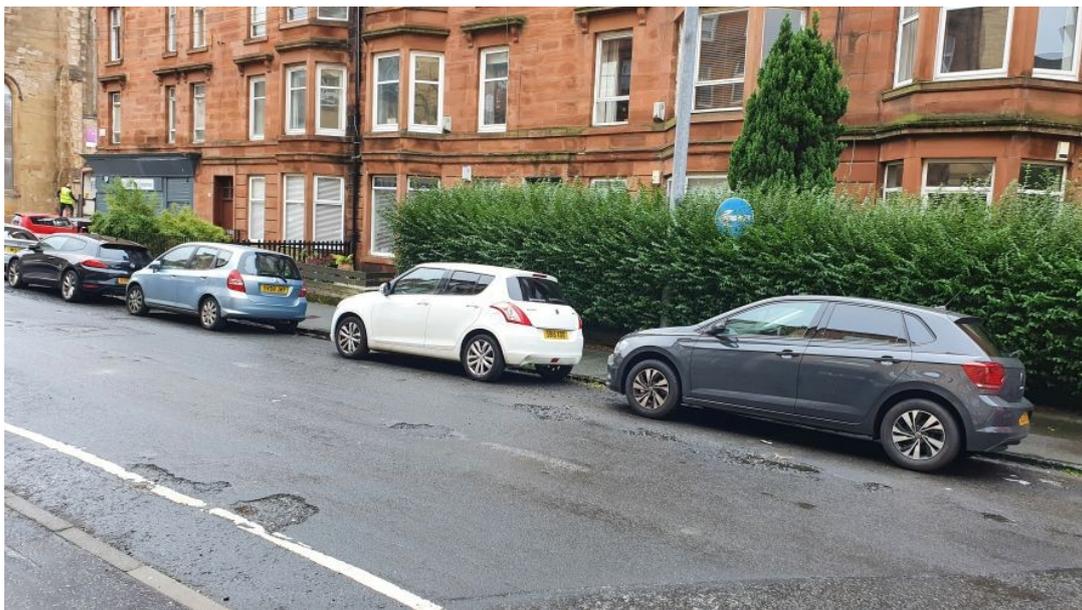
10) Roslea Drive

- a) One-way signage obscured by vegetation.
- b) Poor condition of road surface in multiple locations.

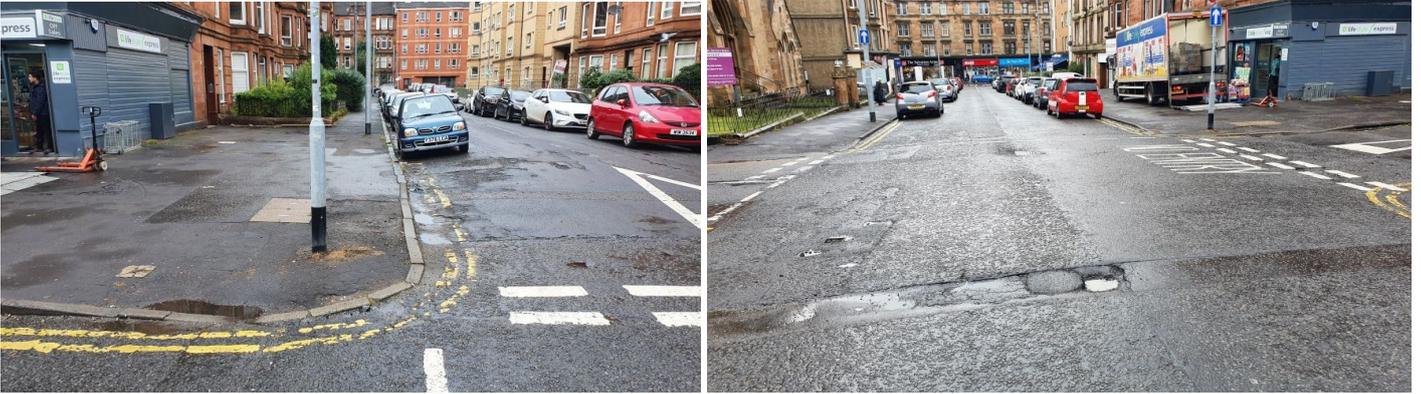
11) Roslea Drive at Whitehill Street

- a) Poor condition of road surface in multiple locations, at Whitehill Street/Roslea Drive junction.
- b) Poor condition of footway surface in multiple locations.
- c) Poor condition of kerbs at crossing points.
- d) Poor condition of road markings.
- e) Blocked gully as mentioned above.
- f) Note use of kerb and footway as a loading bay by multiple large goods vehicles servicing the shop on a daily basis.

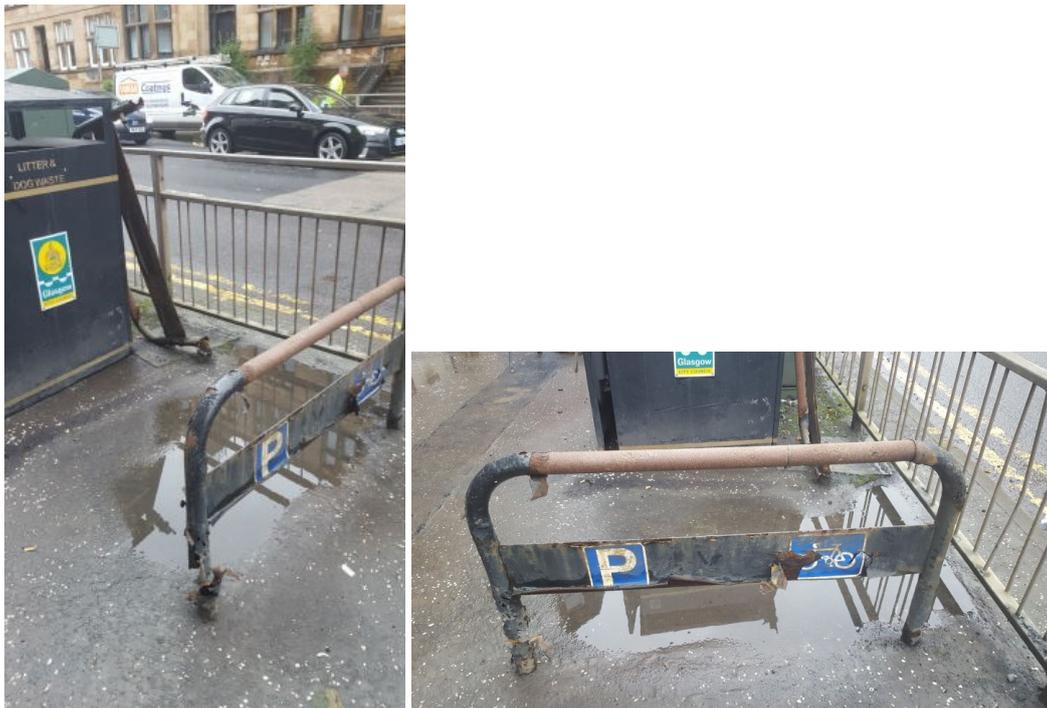
12) Alexandra Parade

- a) Cycle stands failed/degraded on Alexandra Parade outside Hardware Hut (No. 660).

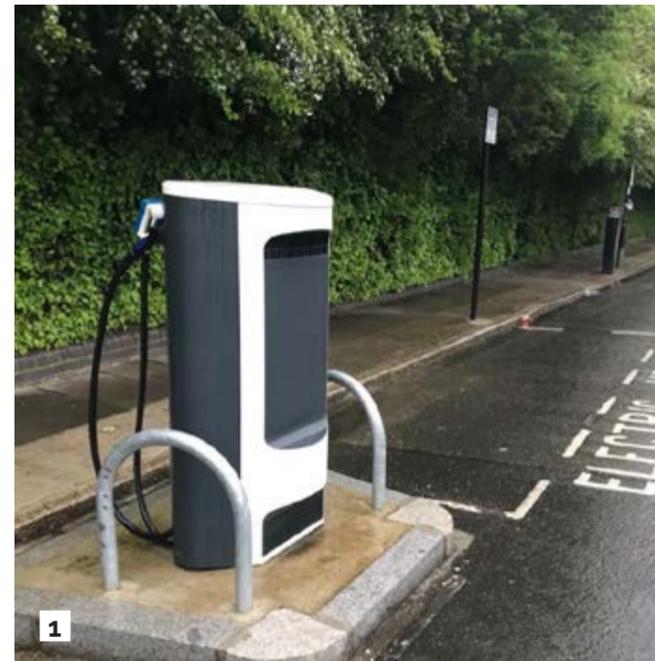
1 - an example of acceptable EV charging point placement within the public realm.

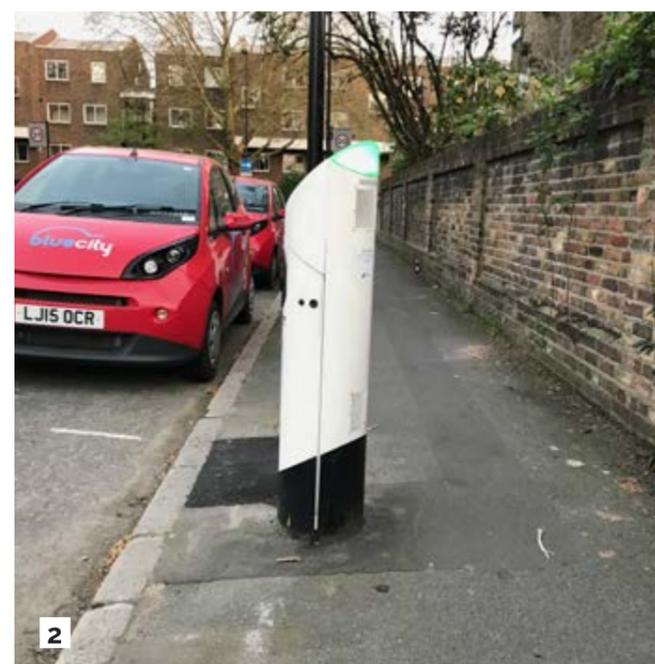
2 - an example of unacceptable EV charging point placement within the public realm.
